INTELLIGENT
DESIGN
ENGINEERING

October 24, 2016

At your request, a visit was made to the referenced address on October 20, 2016 to determine the structural requirements for removing two walls. *All directions are given with respect to someone facing the front of the house from the street.*

WALL REMOVAL PLAN

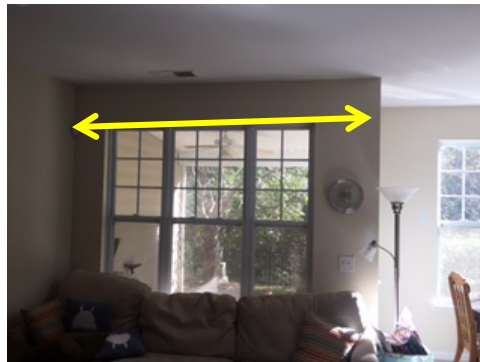
The rear wall of the living room and the wall running from front to back at the left of the dining room are to be removed. The left dining room wall is non-load bearing and can be removed or altered as desired. The rear wall of the living room, however, is load bearing. See the photo below.

The removal of this wall requires the installation of a new dropped (3)-1 $\frac{3}{4}$ "x9 $\frac{1}{4}$ " LVL spanning approximately 9'-0". The left side of the beam must be supported with (3)-2x4 studs set in the left living room wall and should bear over the existing continuous concrete footing between units. The right bearing end of the beam, which is also the left bearing end of the existing beam over the dining room should be supported with a new 5 $\frac{1}{4}$ "x5 $\frac{1}{4}$ " PSL column. The column should be placed directly under the existing beam and the new beam should be supported on the side of the column with a new Simpson HUCQ612-SDS concealed flange hanger. The new column should be attached at the bottom with a Simpson ABW66z post base. The contractor must verify at least 6 square feet of continuous concrete footing under the new post or add a new 30"x30"x10" concrete spot footing directly below the post bearing over 2,000psf bearing soil. Refer to the wall removal plan attached to this report for clarification and relevant information.
